HEADQUARTERS
39TH ENGINEER BATTALION (COMBAT) (ARMY)
APO 96316

SUBJECT: Operational Report - Lessons Learned (RCS CSFOR - 65), for
Quarter Period Ending (31 January 1967)

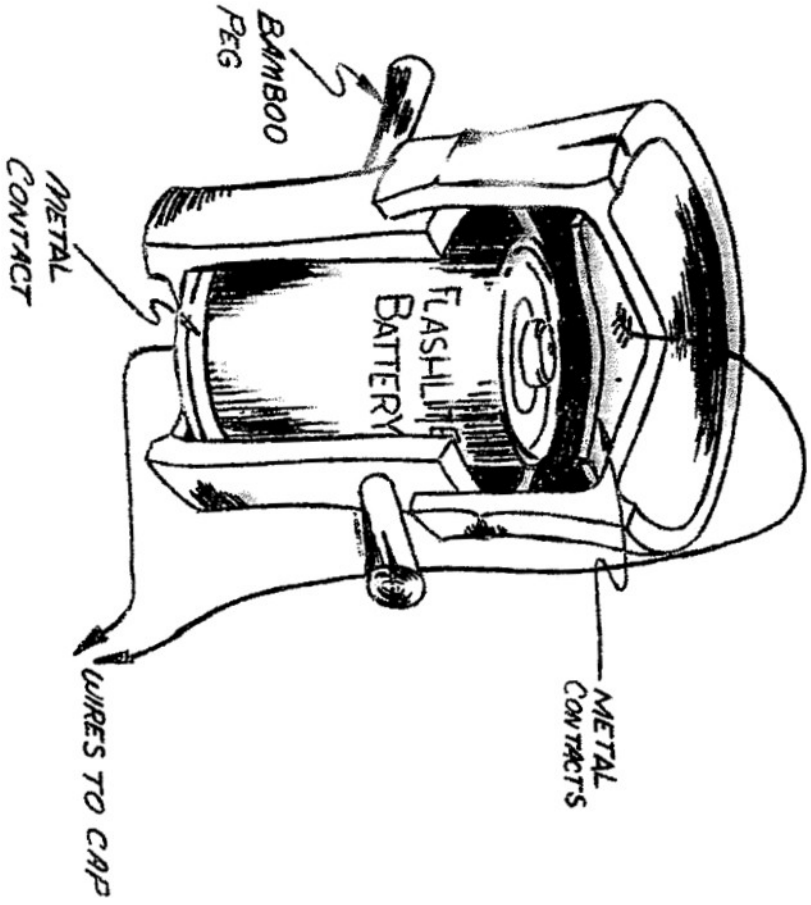
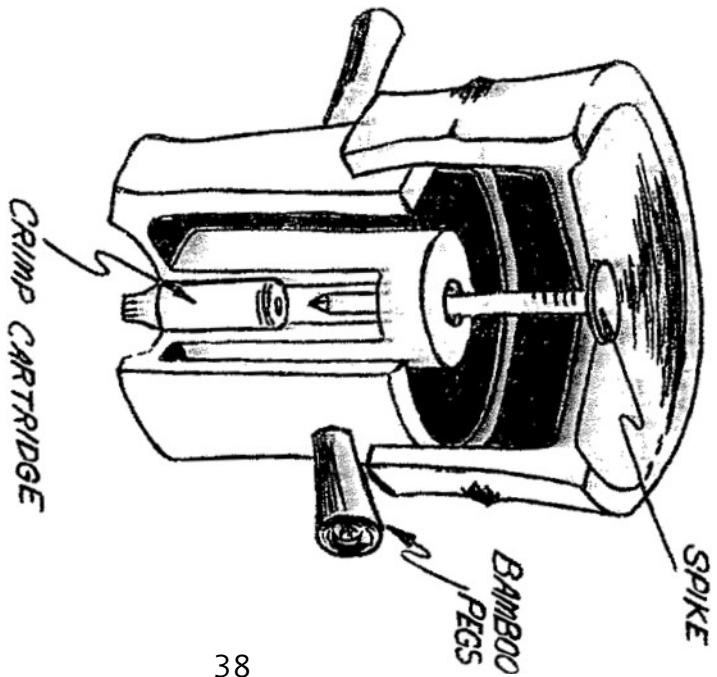
= TYPES OF FIRING DEVICES =

NOTE:
METAL CONTACTS WEDGED
IN TOP AND BOTTOM OF FIRING
DEVICE

e. The device was found buried with the overlapping lip on the top, thus the moving part is forced to crush down the earth and rock filled in around and under it. Therefore depending on the type of soil and length of time buried, it can take from twenty (20) pounds to many hundreds of pounds to set the device off.
